C25(88)

Level 2.5

Repair Documentation

V 1.2

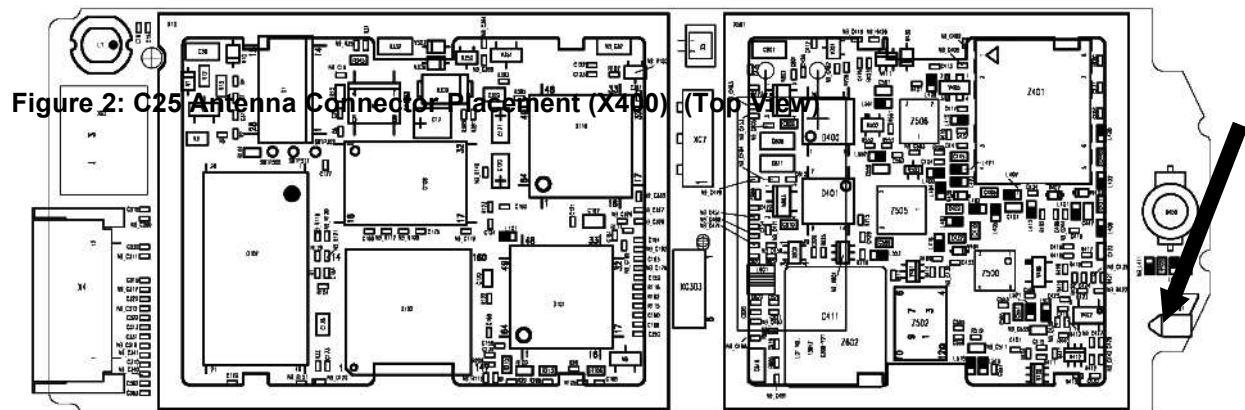
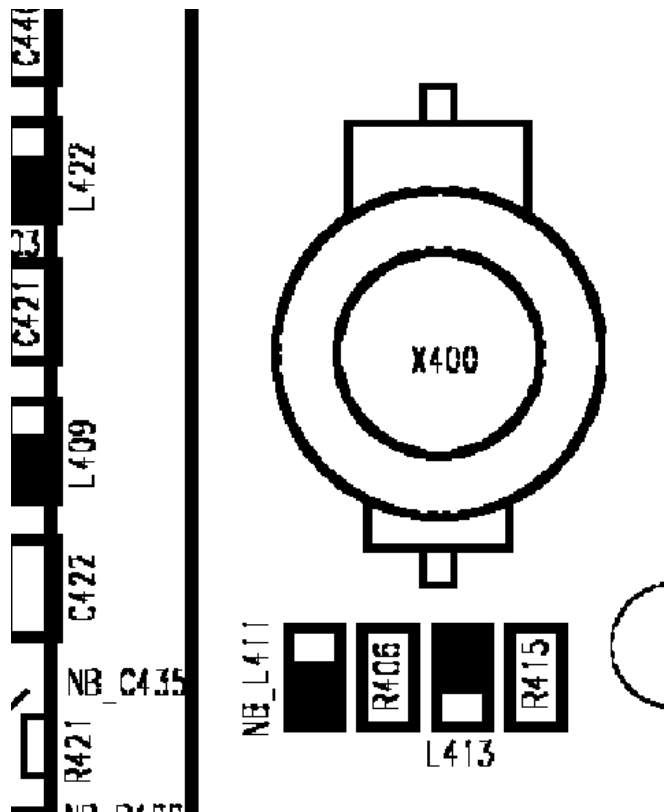
Figure 1: C25 Board Antenna Connector Side (Top View)

Network Search when using the external antenna
(carkit)
No location update possible on external antenna (carkit)

Output power problems on the external antenna
No location update possible

The Antenna Connector is a mechanical switch operated by the RF plug of a carkit or, for testing purposes, of an RF clip.

Use hot air blower to remove defective connector
Avoid excessive heat!
Watch surrounding components!

Resolder new connector afterwards.

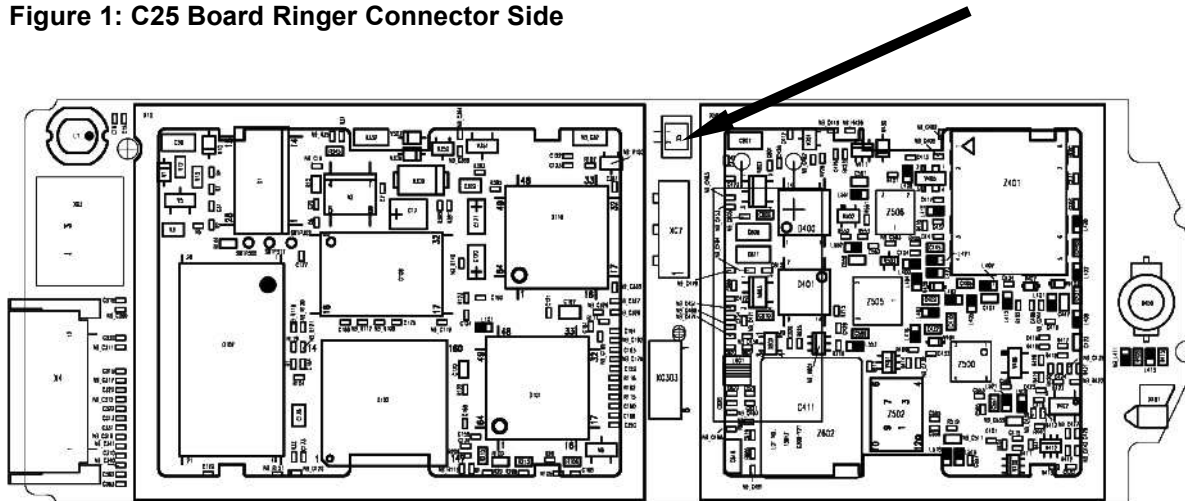
Figure 1: C25 Board Ringer Connector Side

Problems with the handset ringer. No ringer tone audible.

The connector X5 is connecting the main board of the C25 with the piezo ringer through a two pin cable.

Visually check the connector. Watch for bent contacts and dry joints.

Resolder dry soldering joints.
If the connector is physically damaged use hot air blower or wick to remove defective connector.
Avoid excessive heat!
Watch surrounding components!

Resolder new connector afterwards.

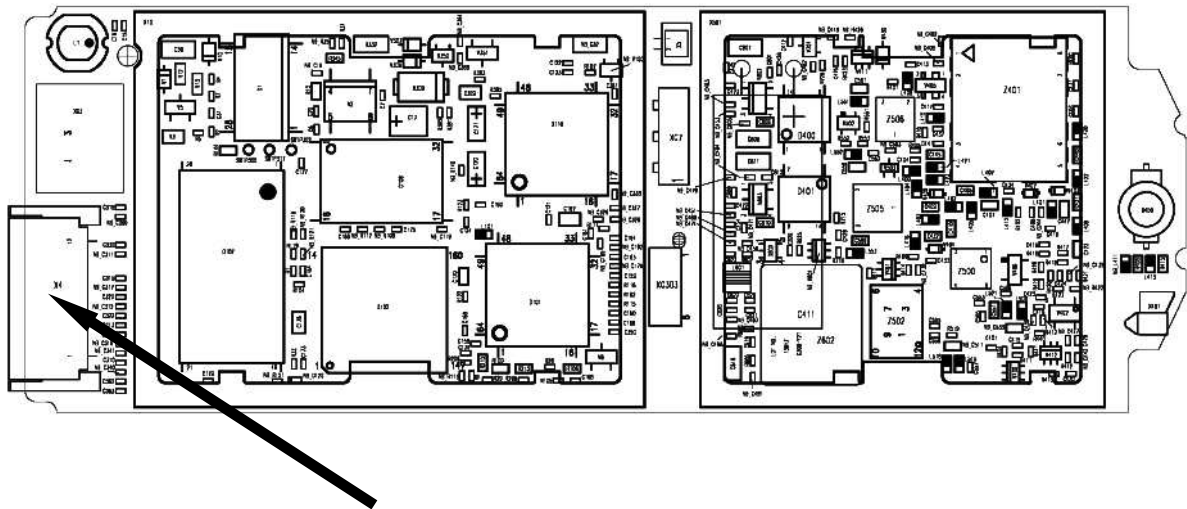
Figure 1: C25 Board Bottom Connector Side

Charging problems.
Problems with external loudspeaker or microphone
when using a car kit.
Problems with accessories connected at the bottom
connector.

Visually check the bottom connector. Watch for dry joints!

Use hot air blower remove defective bottom connector.
Avoid excessive heat!
Watch surrounding components!

Resolder new bottom connector afterwards.

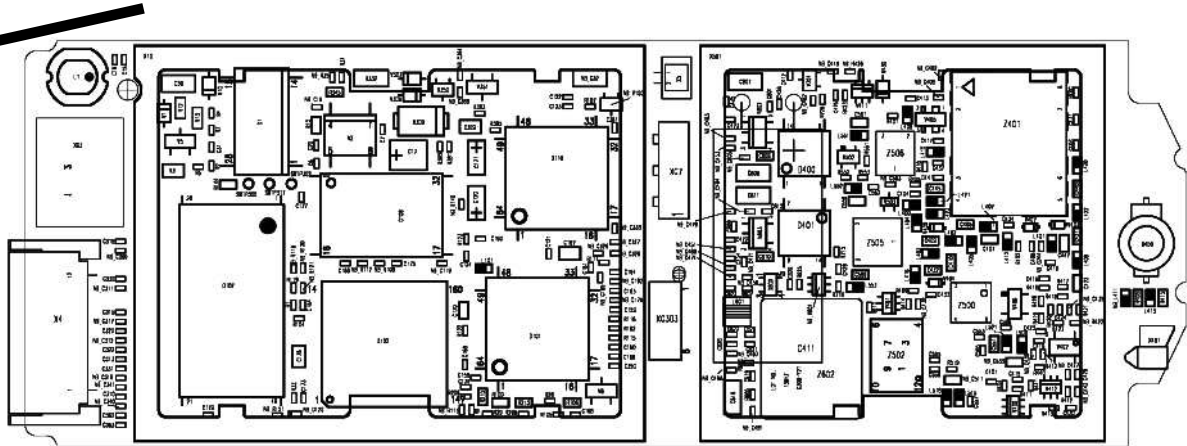
Figure 1: C25 Board 18 μ H Coil (L201) Side

The 18 μ H coil is used in the step up converter which is generating a 5.4 V supply voltage for the power amplifier out of the 2.8V battery voltage.

If the coil is mechanically damaged (broken) it produces heavy interference with the acoustical elements of the C25 resulting in a loud humming noise in the earpiece.

A broken coil can easily be diagnosed by trying to move it with two fingers. If it moves, the core is broken and the coil has to be replaced.

Use hot air to remove defective coil.
Avoid excessive heat!
Watch surrounding components!!

Resolder new coil afterwards

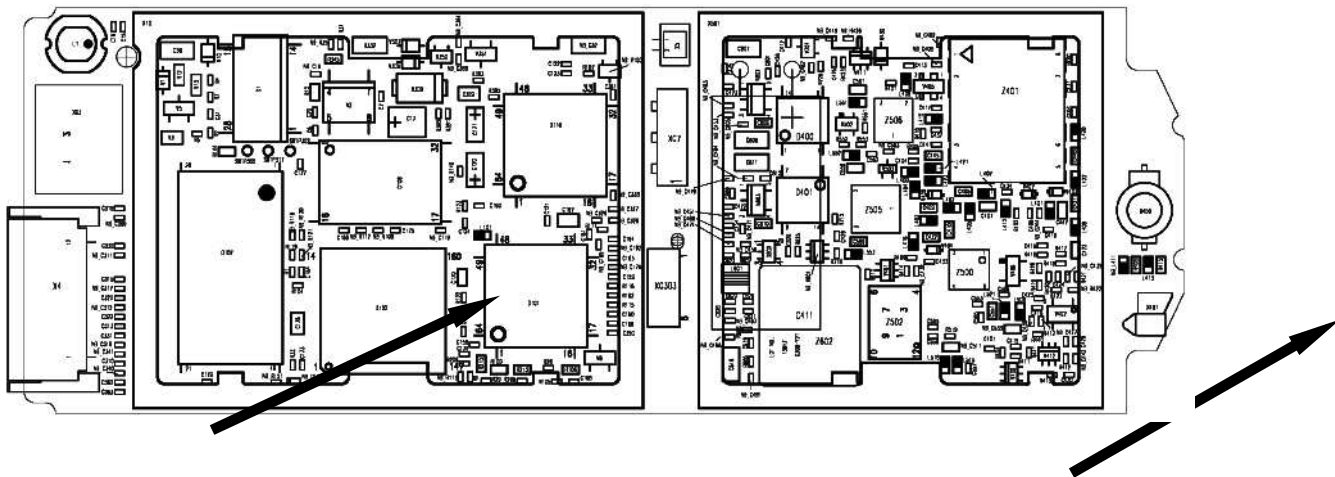
Figure 1: C25 Board Antenna Spring Side

Power problems on the **internal** antenna of the handset
only.

Visually check the status of the spring. Bent or oxidated springs have to be replaced.

Use soldering iron to remove defective spring.
Avoid excessive heat!
Watch surrounding components!

Resolder new spring afterwards.

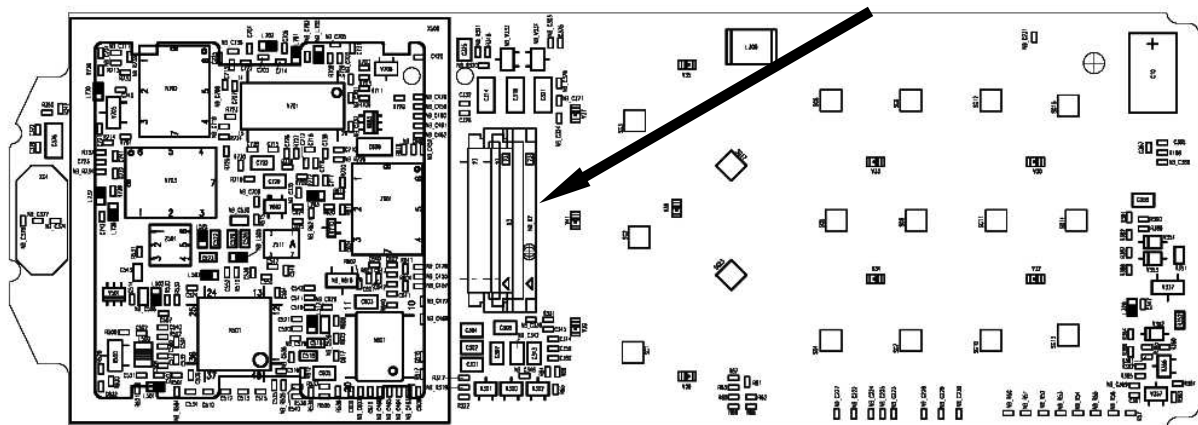
Figure 1: C25 Board Display Connector Side

Display problems.
Missing Lines or columns on the LCD.

Visually check the status of the connector. Check the opening/closing mechanism and watch for dry joints.

Use soldering iron to resolder dry joints or use hot air blower to remove defective connector.

Resolder new connector afterwards.

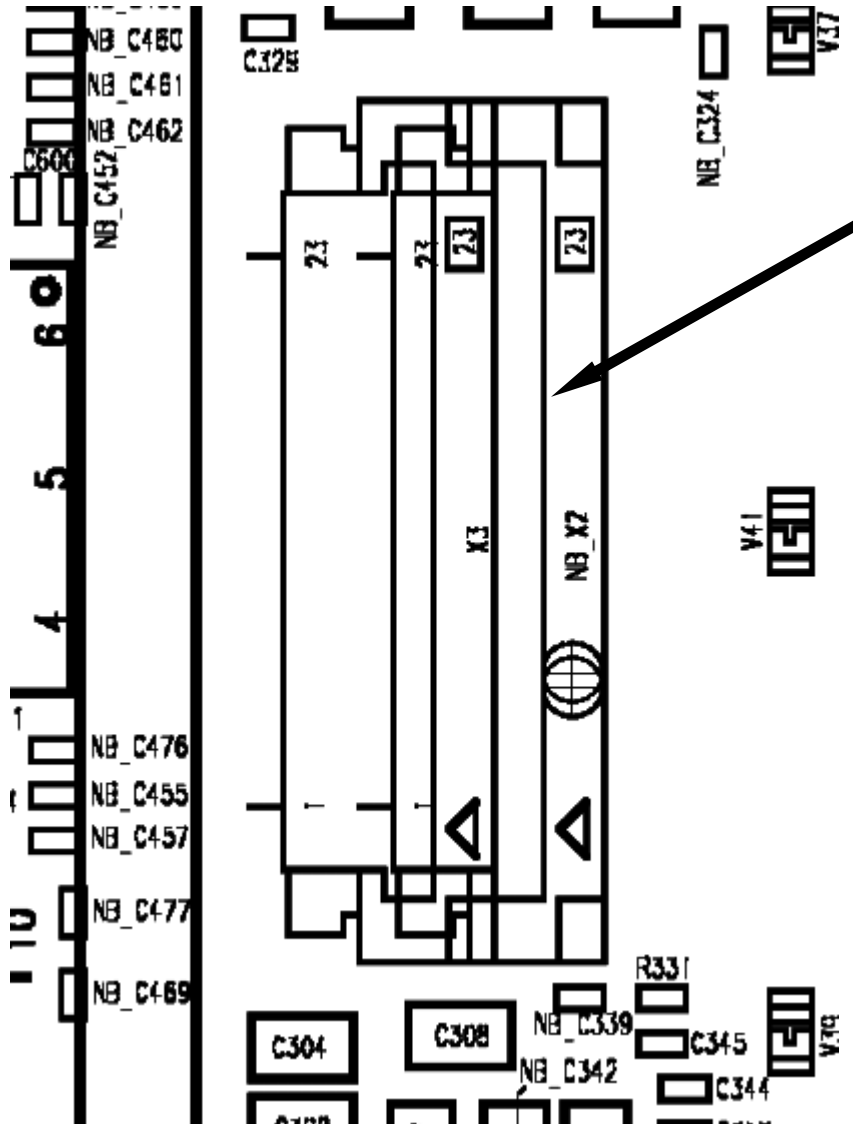
Figure 2: C25 Display Connector (X3) and C2588 Display Connector (X2) Placement (Top View)

Remark: Both C25 and C2588 use the same connector, but the placement position is slightly different!

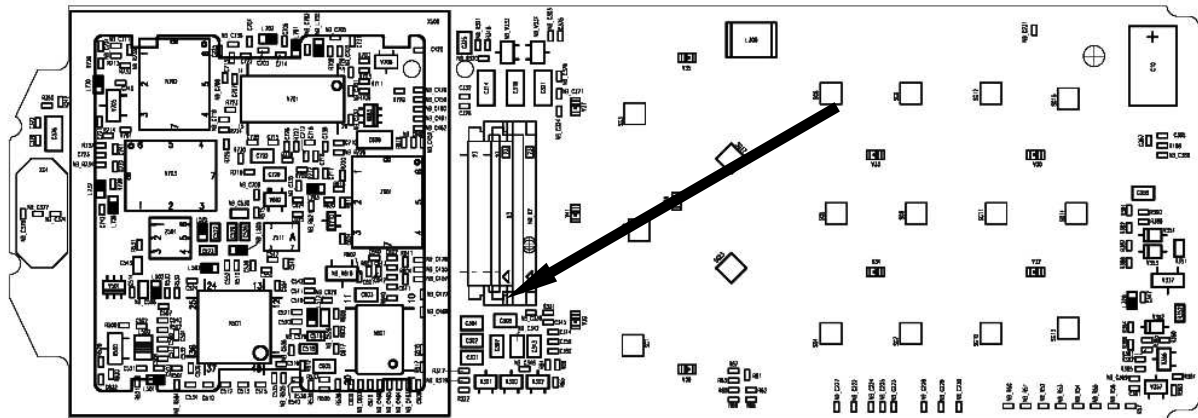
Figure 1: C25 Board Display Capacitor Side

The display is not working at all or shows strange characters.

The capacitors are used to buffer the supply voltage of the display controller. Especially C308 has occasionally been found defective. Check the status of the capacitors by measuring its capacitance with an appropriate measurement device. The capacitance must be in the 220nF range. Defective caps often have a lower capacitance around 100nF.

Use hot air blower or soldering iron to remove defective capacitor.
Avoid excessive heat!
Watch surrounding components!

Resolder new capacitor afterwards.

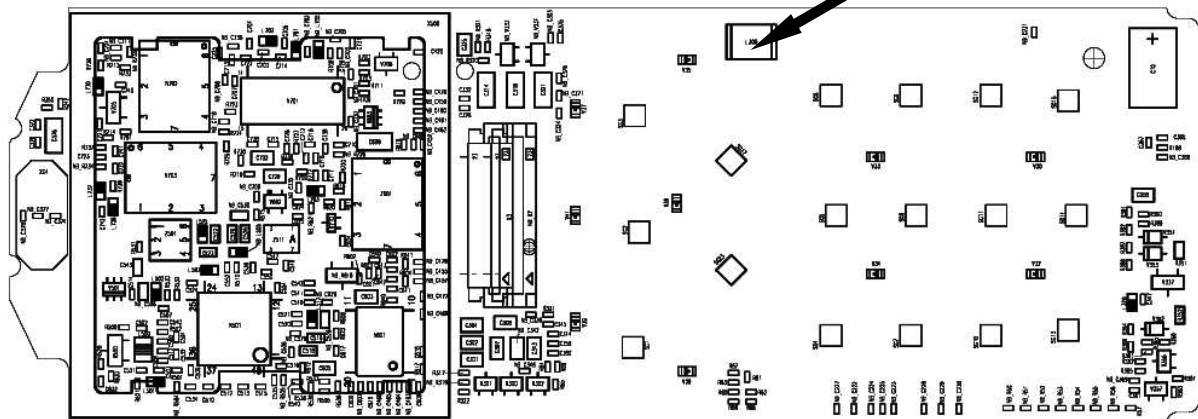
Figure 1: C25 Board Ringer Coil Side

The handset ringer (buzzer) is not working or the
Ringer level is too low

The coil is used to generate the voltage to operate the piezo ringer. If it is defective, the ringer cannot work anymore.
Check the status of the coil by measuring its resistance with a multimeter. The resistance must be very low. Also broken coils have to be replaced.

Use hot air blower or soldering iron to remove defective coil.
Avoid excessive heat!
Watch surrounding components!

Resolder new coil afterwards.

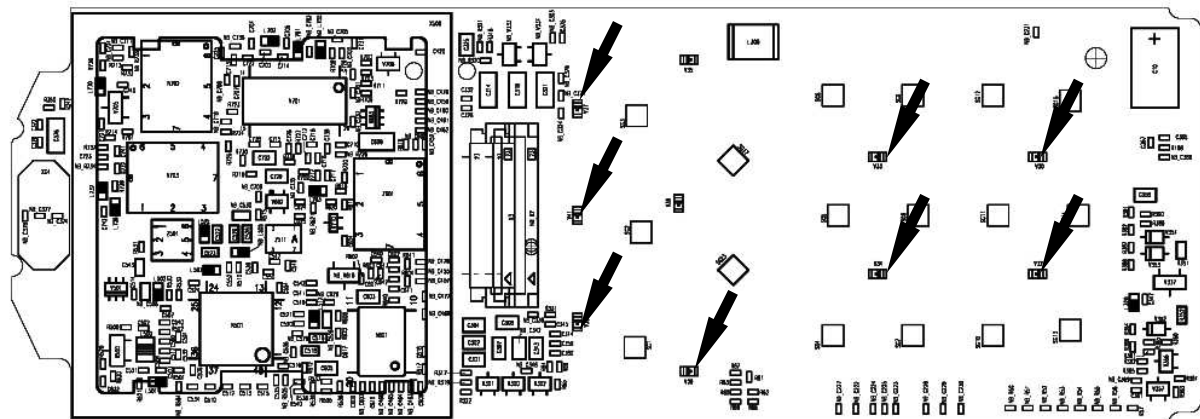
Figure 1: C25 Board LED Side

The display/keypad illumination is not working properly.

The nine LEDs are providing the illumination both for the display and for the keyboard. Just switch on the phone without upper case and remove the keyboard. Now visually check the function of the LEDs.

Use hot air blower or soldering iron to remove defective LED.

Watch the polarity of the LED!

Resolder new LED afterwards.
