E10 / S6 Power GSM /S8 GSM

Level 2.5

Repair Documentation

V 1.2

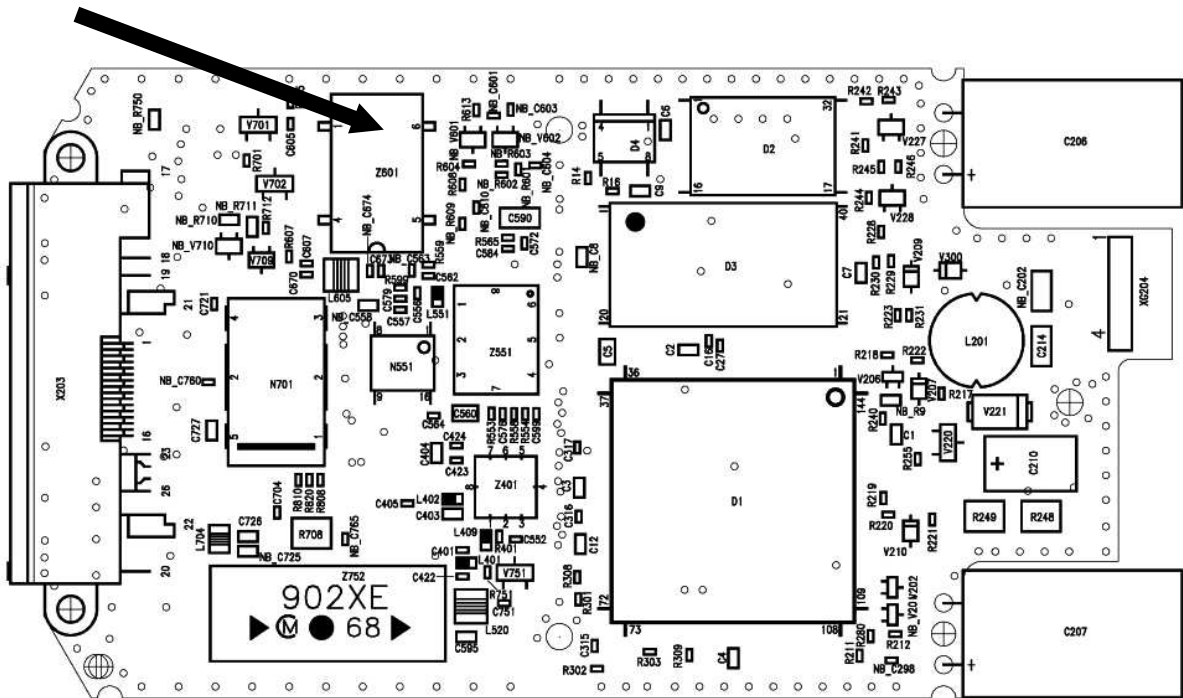
Figure 1: E10 / S6 Power GSM Board VCXO Side

Network Search
Handset not logging into network

Frequency error in synchronized mode >90 Hz
No location update possible

The VCXO (Voltage Controlled Crystal Oscillator) is responsible for generating the 13 MHz reference frequency of the handset.
If it is defective, the handset cannot synchronize to the base station anymore.

If the frequency error is higher than 2kHz, the VCXO has to be replaced.

Use hot air blower to remove defective VCXO.

Resolder new VCXO afterwards.

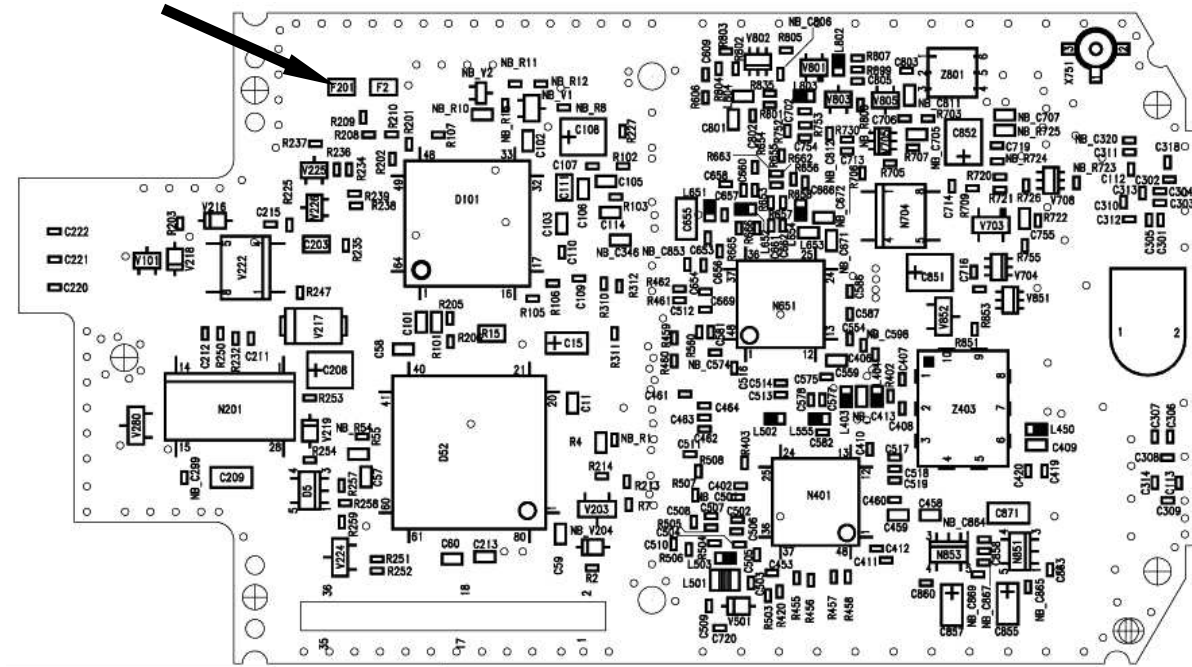
Figure 1: E10 / S6 Power GSM Board 1A Fuse Side

Battery charging not possible

Check the status of the fuse by measuring its resistance with a multimeter. The fuse is defective if the resistance higher than 10 ohms.

Use soldering iron to remove defective fuse.
Avoid excessive heat!
Watch surrounding components!

Resolder new fuse afterwards.

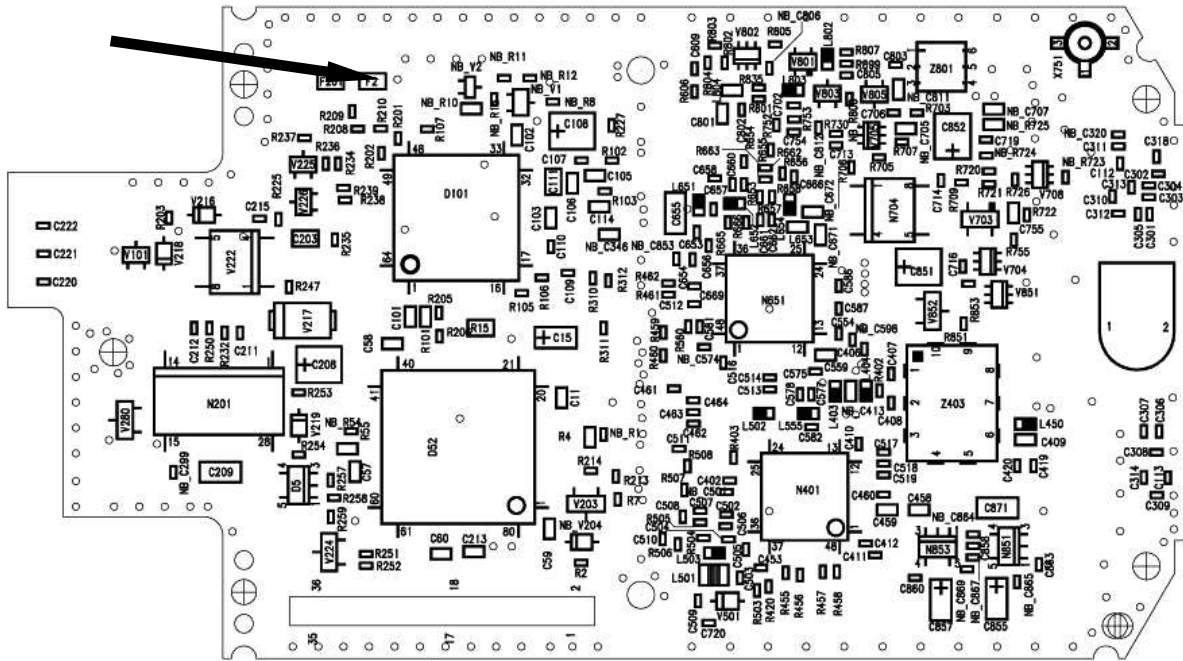
Figure 1: E10 / S6 Power GSM 0.25A Fuse Side

Supplying of external accessories through the handset's bottom connector is not possible

Check the status of the fuse by measuring its resistance with a multimeter. The fuse is defective if the resistance higher than 10 ohms

Use soldering iron to remove defective fuse.
Avoid excessive heat!
Watch surrounding components!

Resolder new fuse afterwards.

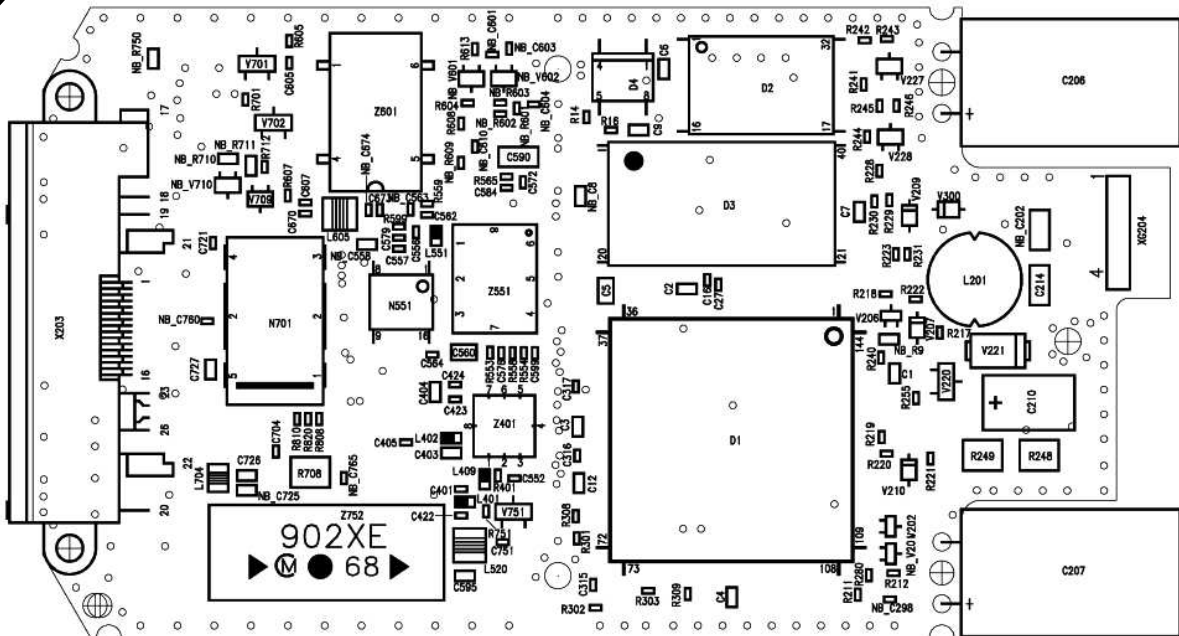
Figure 1: E10 / S6 Power GSM Board Bottom Connector Side

Network search.
Charging or operation in a car kit not possible.

Output power problems on the external and internal antenna.
No location update possible.

Visually check the bottom connector. Watch for dry joints.

Use hot air blower to remove defective connector.
Avoid excessive heat!
Watch surrounding components!

Resolder new connector afterwards.
Make sure that you use just very little flux, otherwise the connector contacts can become dirty.
