C25(88)

Level 2.5

Repair Documentation

V 1.2

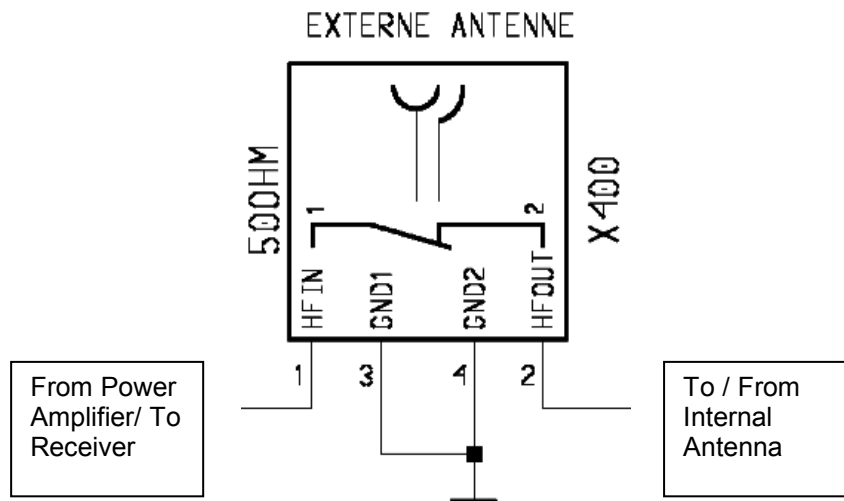
The Antenna Connector is a mechanical switch operated by the RF plug of a carkit or, for testing purposes, of an RF clip.

Normally the RF signal goes to and comes from the internal antenna. Whenever an RF plug is plugged into the antenna connector the connection to the internal antenna is opened and the connection to the external antenna socket is made. See drawing below.
